DATE: April 2022

Independent Arboricultural Consultancy

**TREE PRESERVATION ORDER Application to fell
TPO Ref 685, Llwynderw Primary School, West Cross Road,
Swansea**

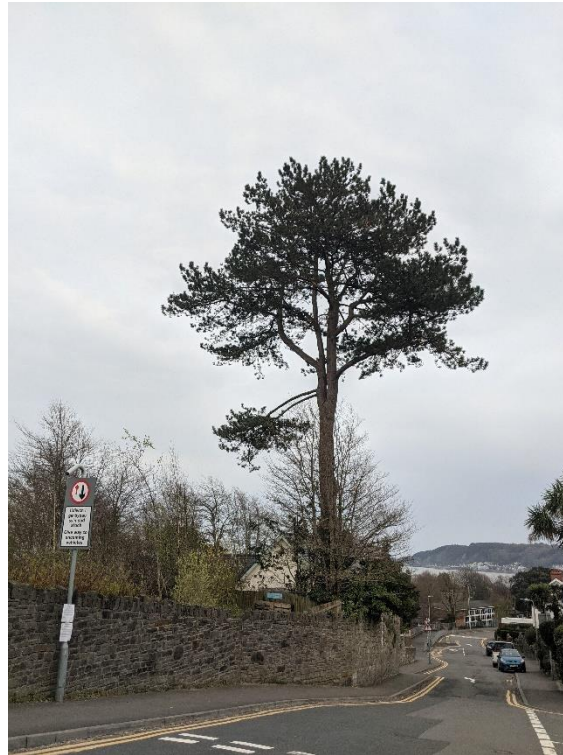
IMAGE 1 (above) The tree viewed from up the hill, opposite the school.

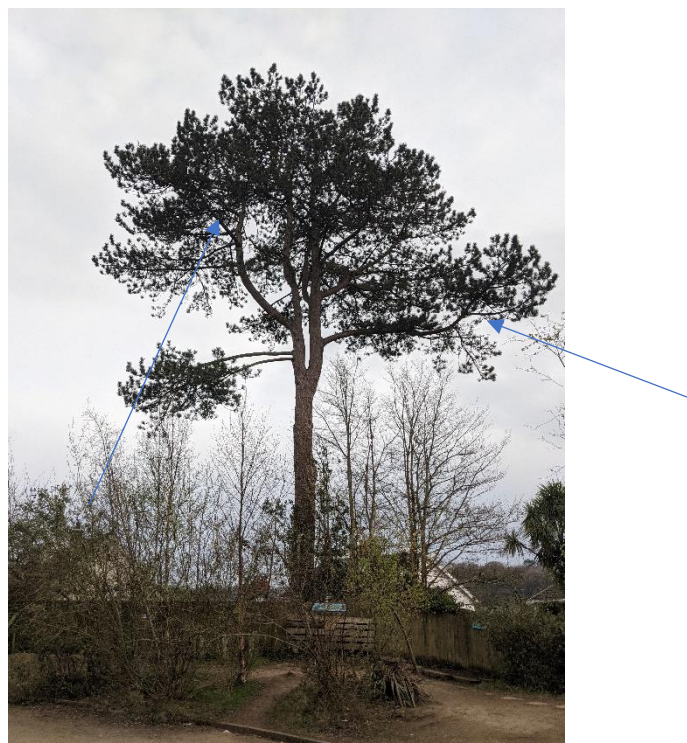
4.1 The tree is a mature specimen. During recent inclement weather, several large branches were shed, some landing in the grounds of the primary school in which the tree is standing. One landed on the neighbouring property, causing damage to the roof. The tree has fine, evergreen foliage which is vulnerable to branch failure. Use of the tapping hammer resulted in bark platelet shedding, which is not expected. Insect bore holes are present on the trunk. The tree has Diplodia tip, and we estimate a future life expectancy of five years. As such, the tree is not suited to long-term retention and there is an increased concern about safety. Further branch loss can be expected. There is only a small area south of the tree for anchoring roots, so little protection against on-shore prevailing winds.

IMAGE 2 (below): The tree viewed from within the school grounds. The left arrow shows a hung-up branch, the right arrow shows where the branch broke that landed in The Lodge.

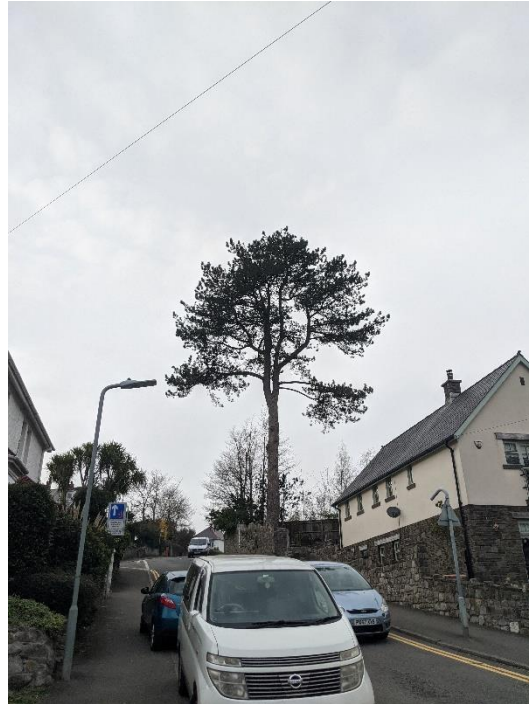
IMAGE3 (above) The trees viewed from below The Lodge.

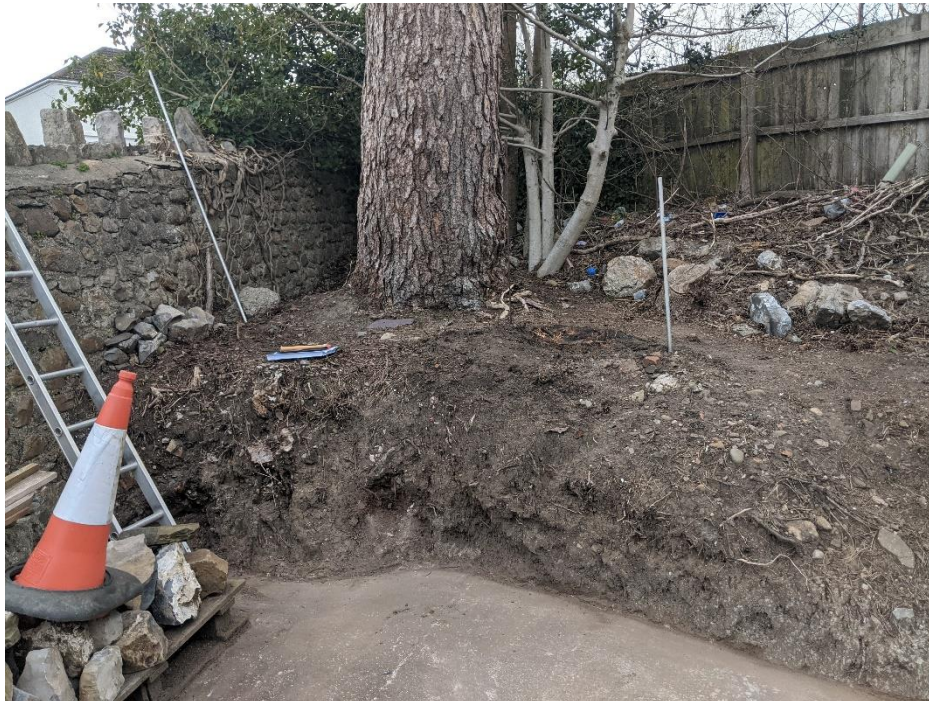
IMAGE4 (below): Ground conditions around the tree. Note that there is little rooting to the south which is where the impact of on-short winds would be.

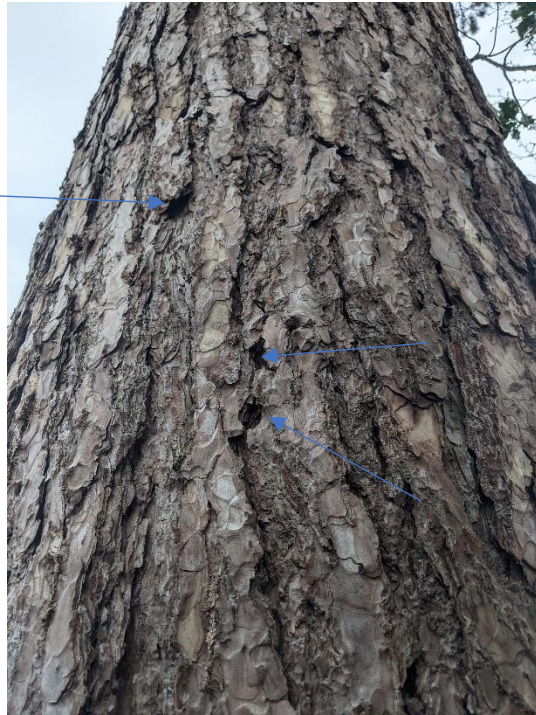
5.1 The tree is a mature, prominent specimen. However, it is in decline and shedding of branches is happening on the surrounding, residential area which includes a primary school to the north and a dwelling with permanent occupancy to the south. The tree is suffering from infestation from a boring insect. It is considered to have fewer than ten years of life, and possibly as few as five years remaining due to its condition.

IMAGE 5 (above): Insect bore holes.

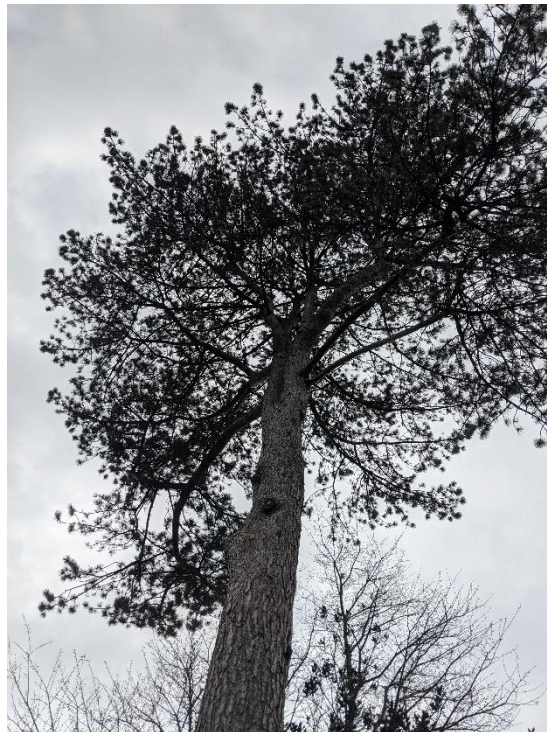
IMAGE 6 (below): The upper crown viewed from within The Lodge.

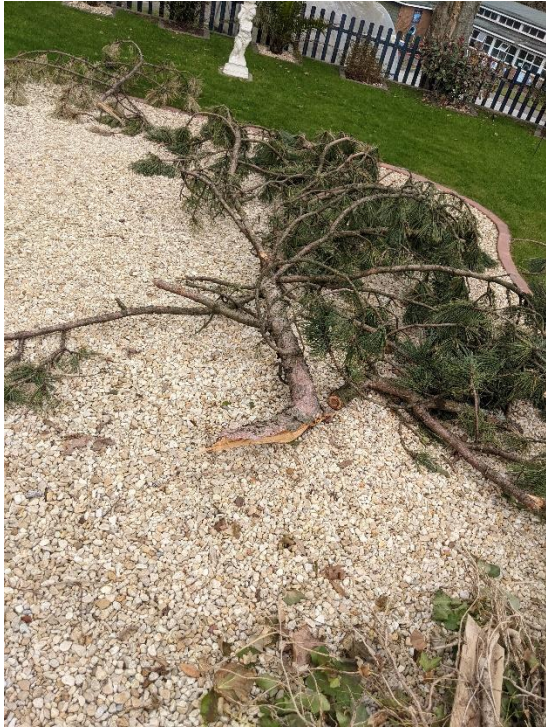
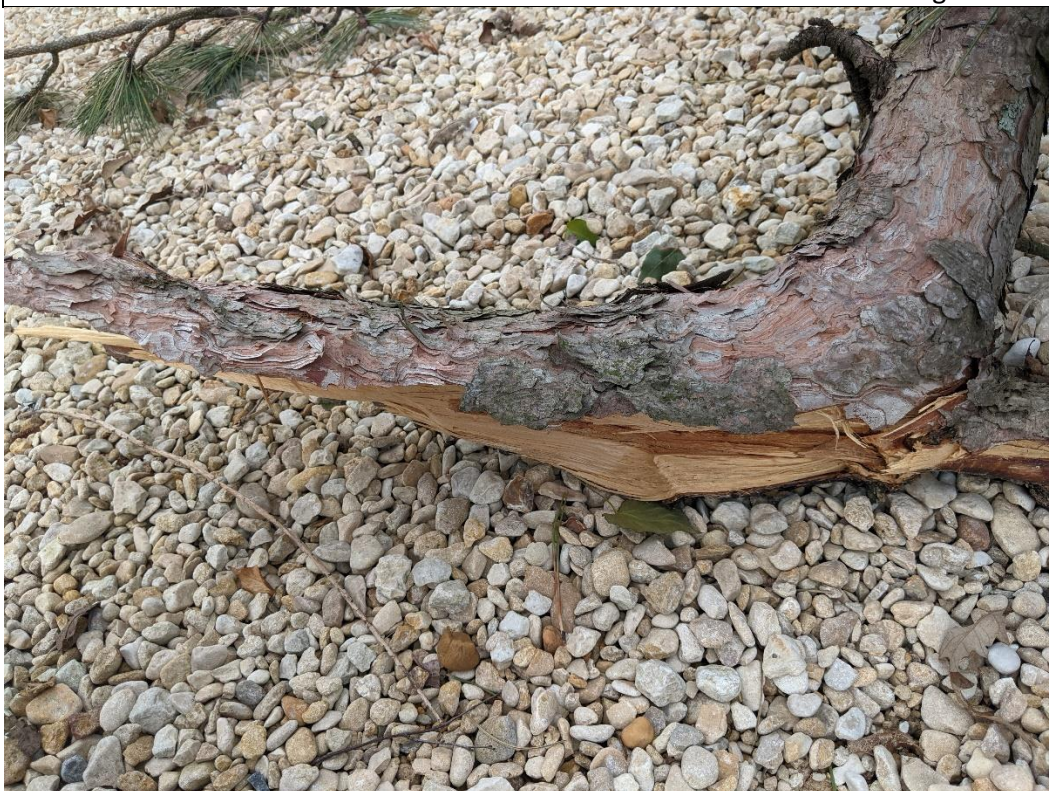
Above & Below: Two views of the branch which broke and landed in The Lodge.

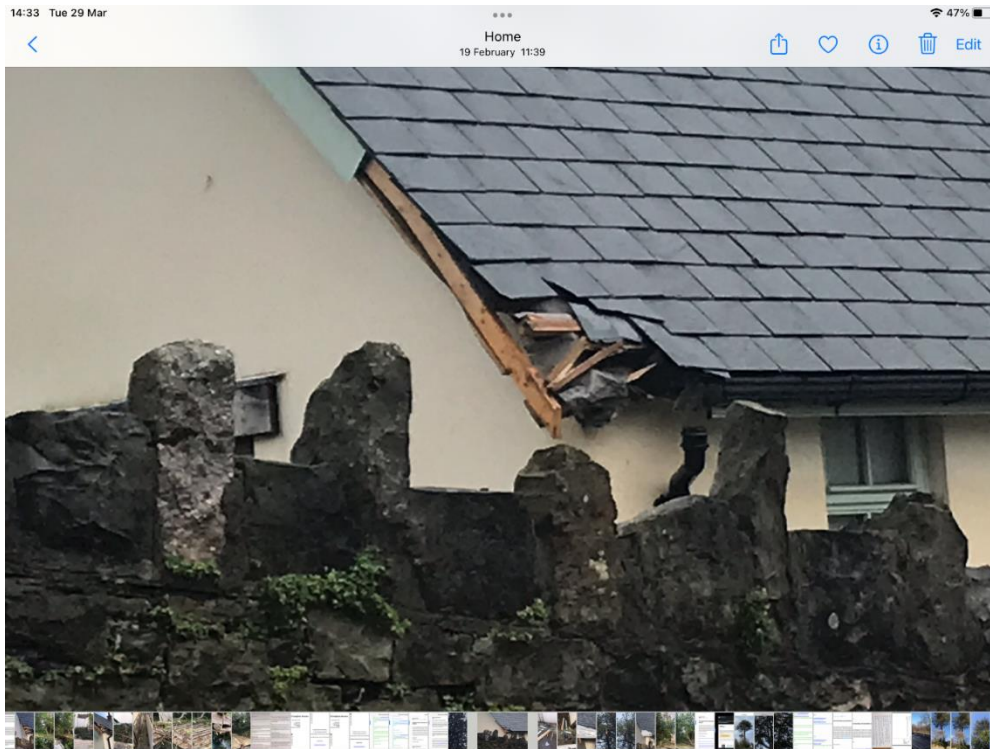
Damage to the roof of The Lodge from the branch fall (above). Cracks to the wall (below)

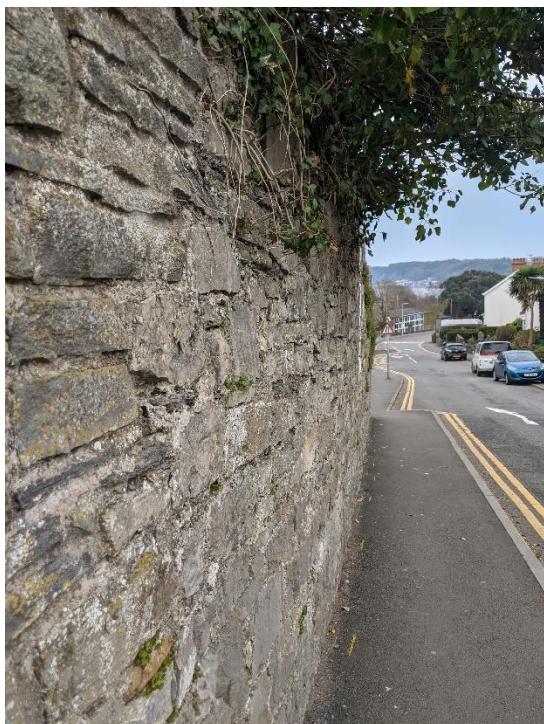
4.2 There is evidence of cracking on the boundary wall which is close to the tree. Whilst this is beyond the scope of this report, it is consistent with rooting damage and presents another potential problem.
